New York State Department of Transportation

Yellow Flag NB2258W022

BIN: 1065318

Location: Span 97, Girder G5 at Pier 96 located within scaffolding platforms installed by contractor which is located above parking lot between 52nd and 53rd Street.

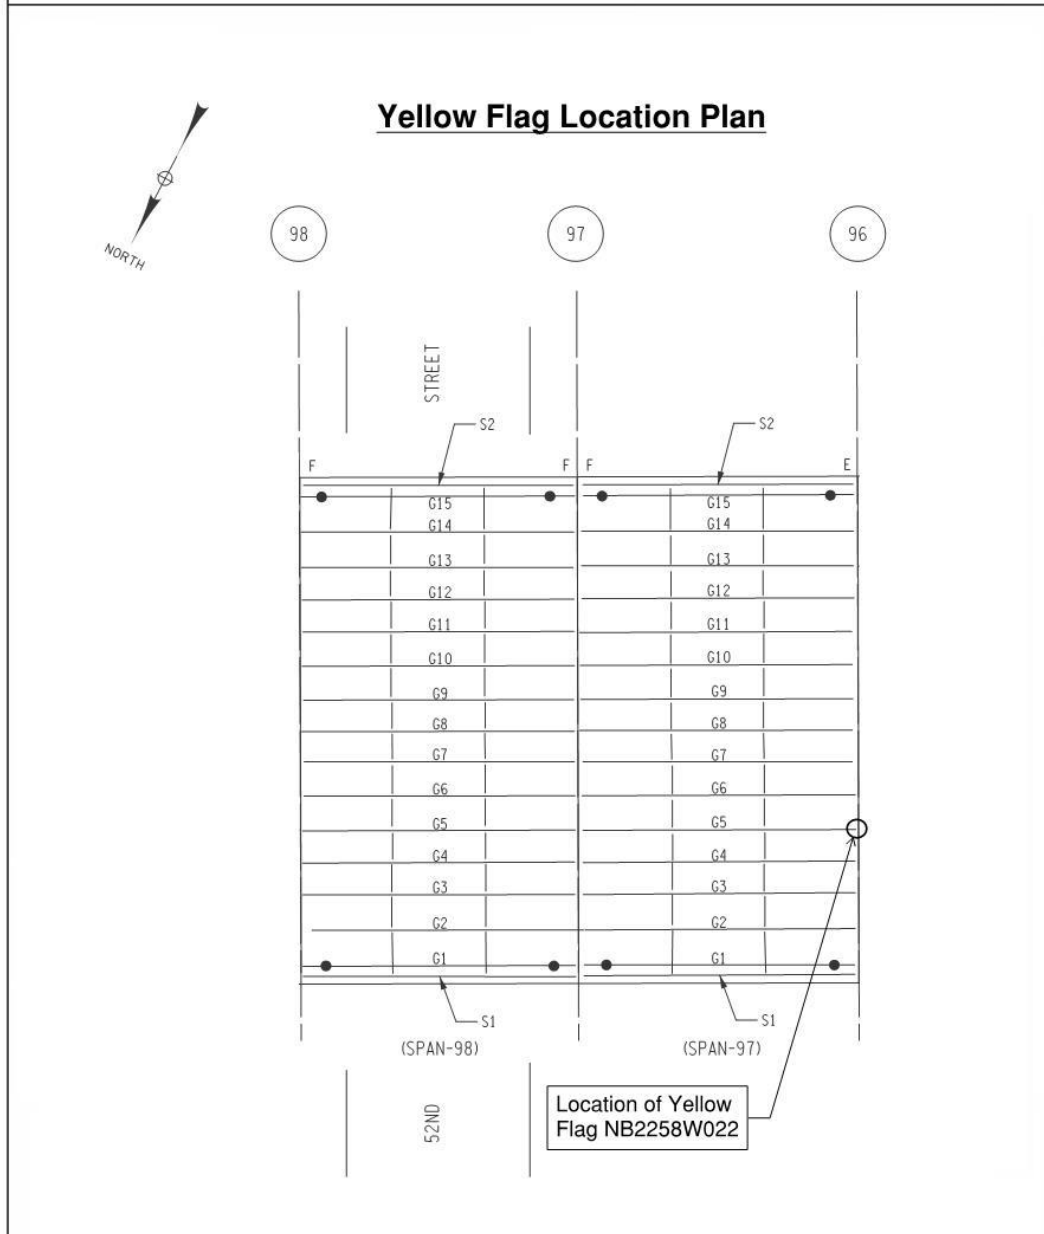
Flag PhotographsPhoto Number: **1**Photo Filename: **22_Flag Location Plan.jpg**Gowanus Expressway
2022 Biennial Inspection - Field SketchBIN: 1065318Team: AA/TSDate: 10/21/2022Span: 97Location: Girder G5 at Pier 96

**wsp****Attachment Description: Yellow Flag Location Plan**

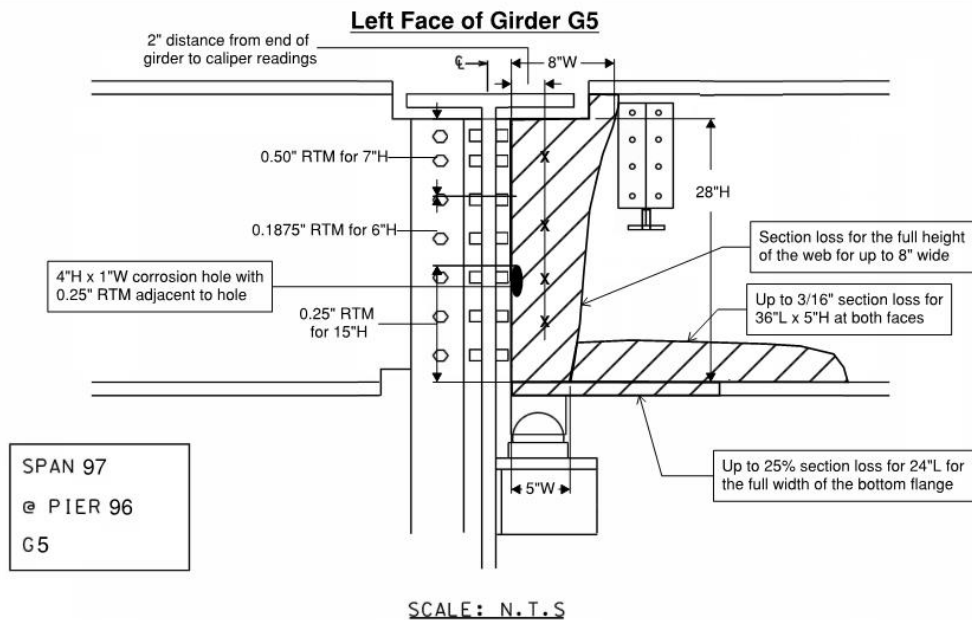
Photo Number: 2

**Section loss Calculations:**

Original girder web thickness = 0.625" (measured)

Localized section loss in web area above bearing = $(0.625 - 0.25) / 0.625 \times 100 = 60\%$ section lossWeb bearing area length = $18 \times 0.625 = 11.25$ "Web bearing area = $0.25 \times 5 + (0.625 - (2 \times 0.1875)) \times 6.25 = 2.81 \text{ in}^2$ Overall web bearing area section loss = $[(11.25 \times 0.625) - 2.81 \text{ in}^2] / (11.25 \times 0.625) \times 100 = 60\%$ section lossShear web area = $(0.25 \times 15) + (0.1875 \times 6) + (0.50 \times 7) = 8.38 \text{ in}^2$ Overall shear web area section loss = $[(28 \times 0.625) - 8.38 \text{ in}^2] / (28 \times 0.625) \times 100 = 52\%$ section loss

Attachment Description: Yellow Flag Condition Sketch

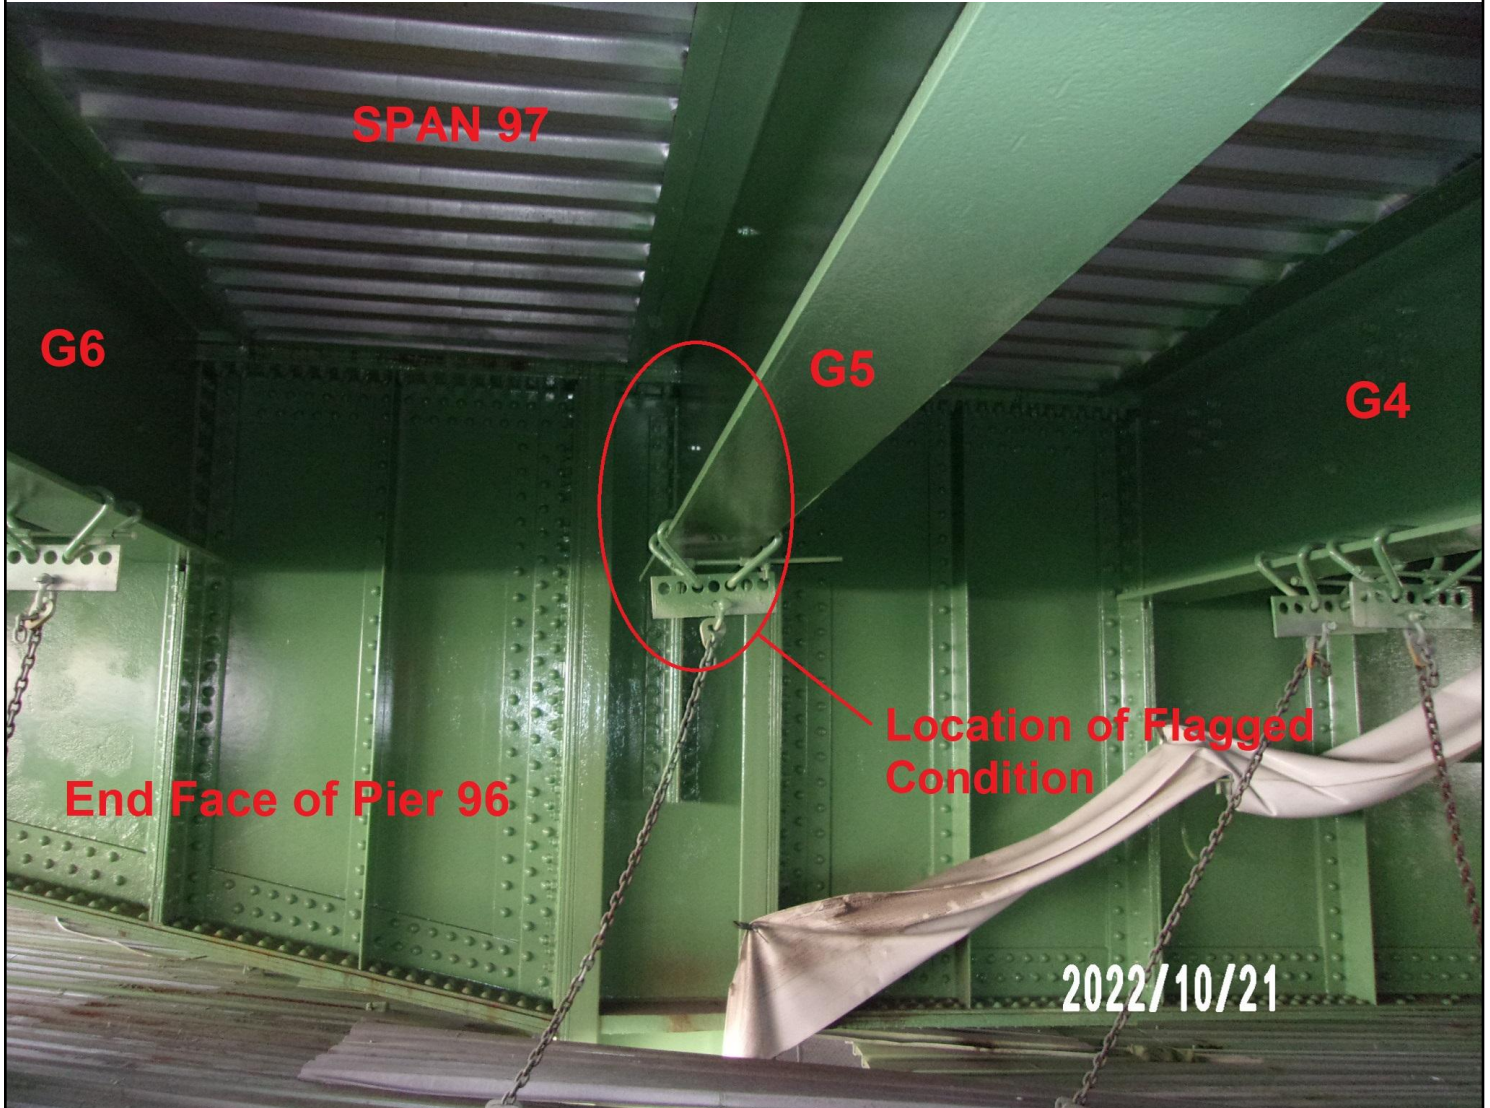
Photo Number: 3

Attachment Description: General view of the flagged condition at Girder G5 in Span 97 at Pier 96. Looking Begin.

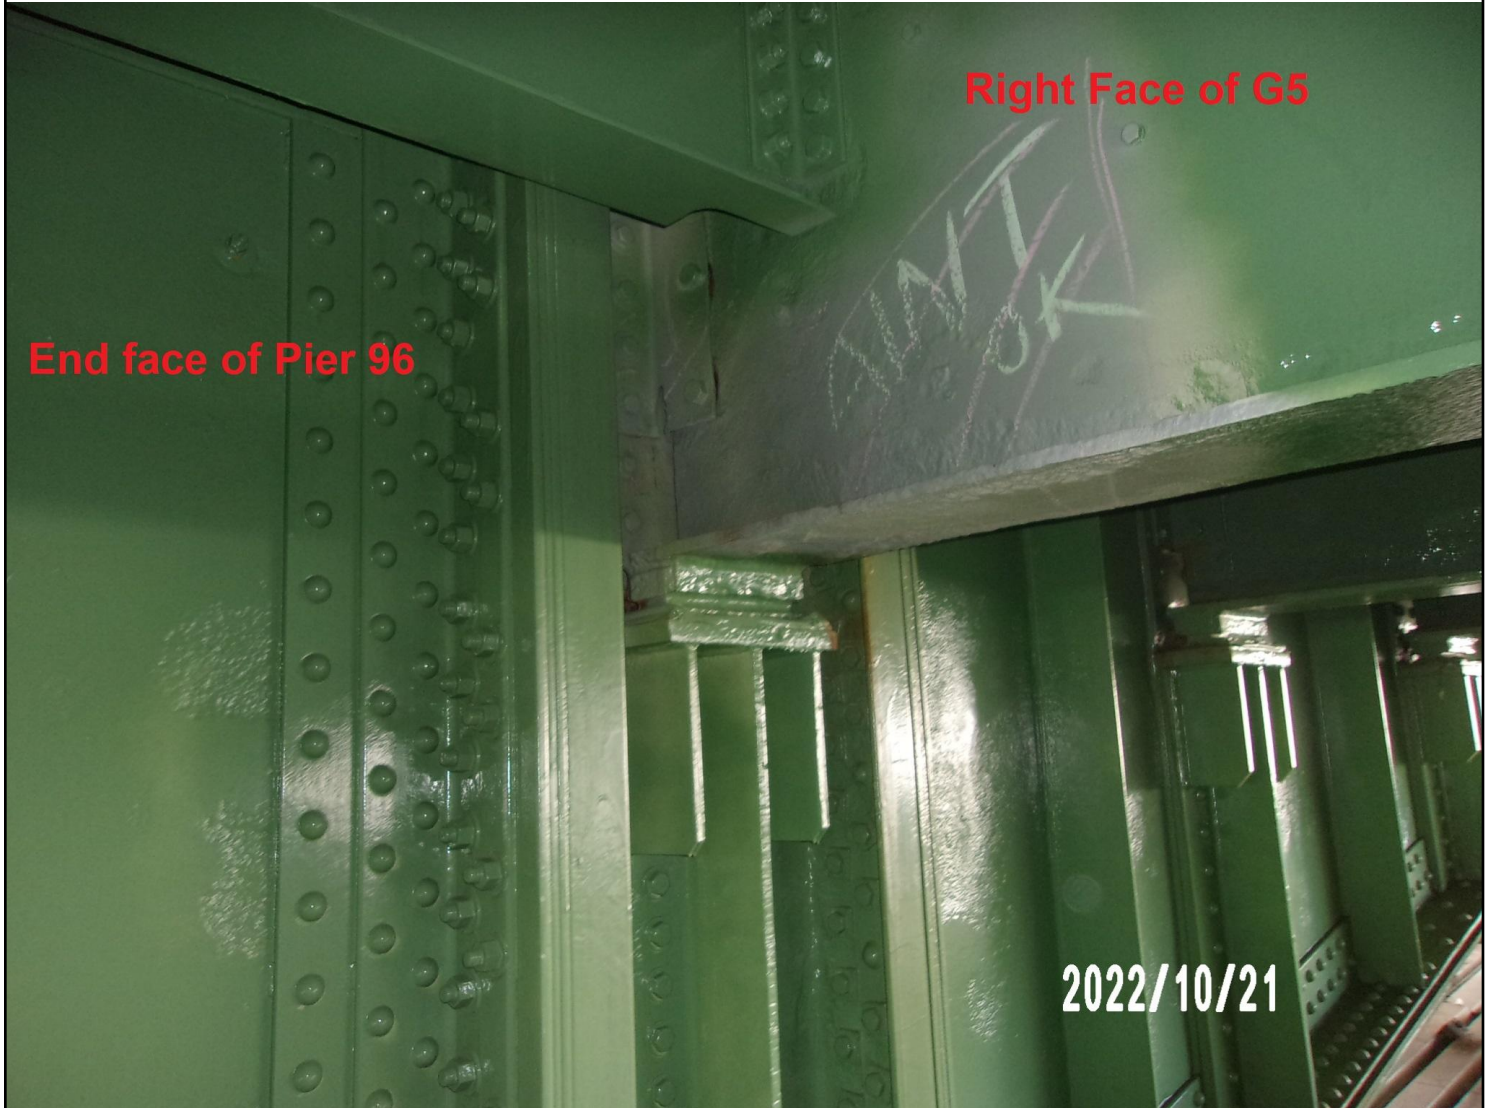
Photo Number: 4

Attachment Description: Close-up general view of Girder G5 in Span 97 at Pier 96. Looking Begin and Left.

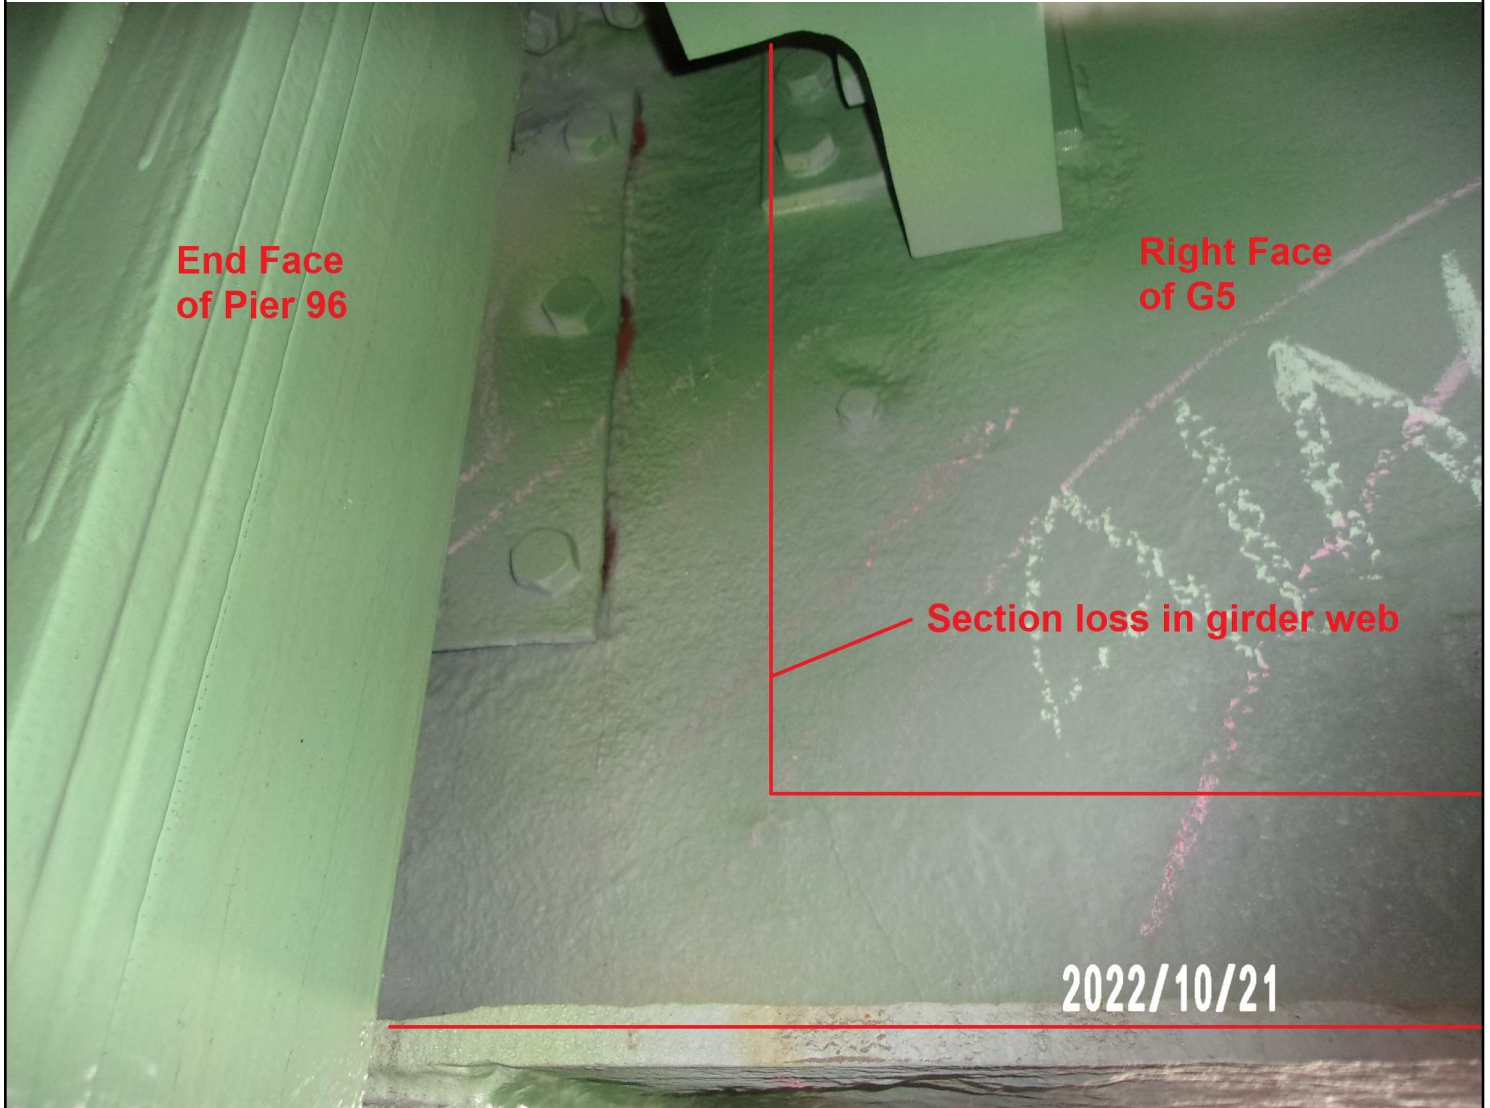
Photo Number: 5

The end of Girder G5 in Span 97 at Pier 96 exhibits severe section loss with 3/16"-1/2" remaining thickness measured (RTM) in the girder web for the full height of the web (resulting in approximately 20%-70% section loss) (Photo 9). The girder end exhibits 4"H x 1"W corrosion hole behind the guide angle approximately 11" from the bottom flange (Photo 8). The lower girder web above the bottom flange exhibits up to 3/16" section loss for 36"L x 5"H at both faces of the girder (Photo 10). The bottom flange of the girder exhibits up to 25% section loss for 24"L for the full width of the flange (Photo 11). The web area directly above the bearing exhibits 60% localized section loss (Photo 7). The overall shear web area section loss is approximately 52%. The overall bearing area web section loss is approximately 60%. (Photos 5 and 6) (refer to Yellow Flag Condition Sketch Photo #2 for more details)

Attachment Description: The right face of Girder G5 in Span 97 at Pier 96. The girder web exhibits severe section loss resulting in approximately 60% localized section loss in web area above the bearing, 52% overall shear web area section loss, and 60% overall bearing area web section loss. Looking Left.

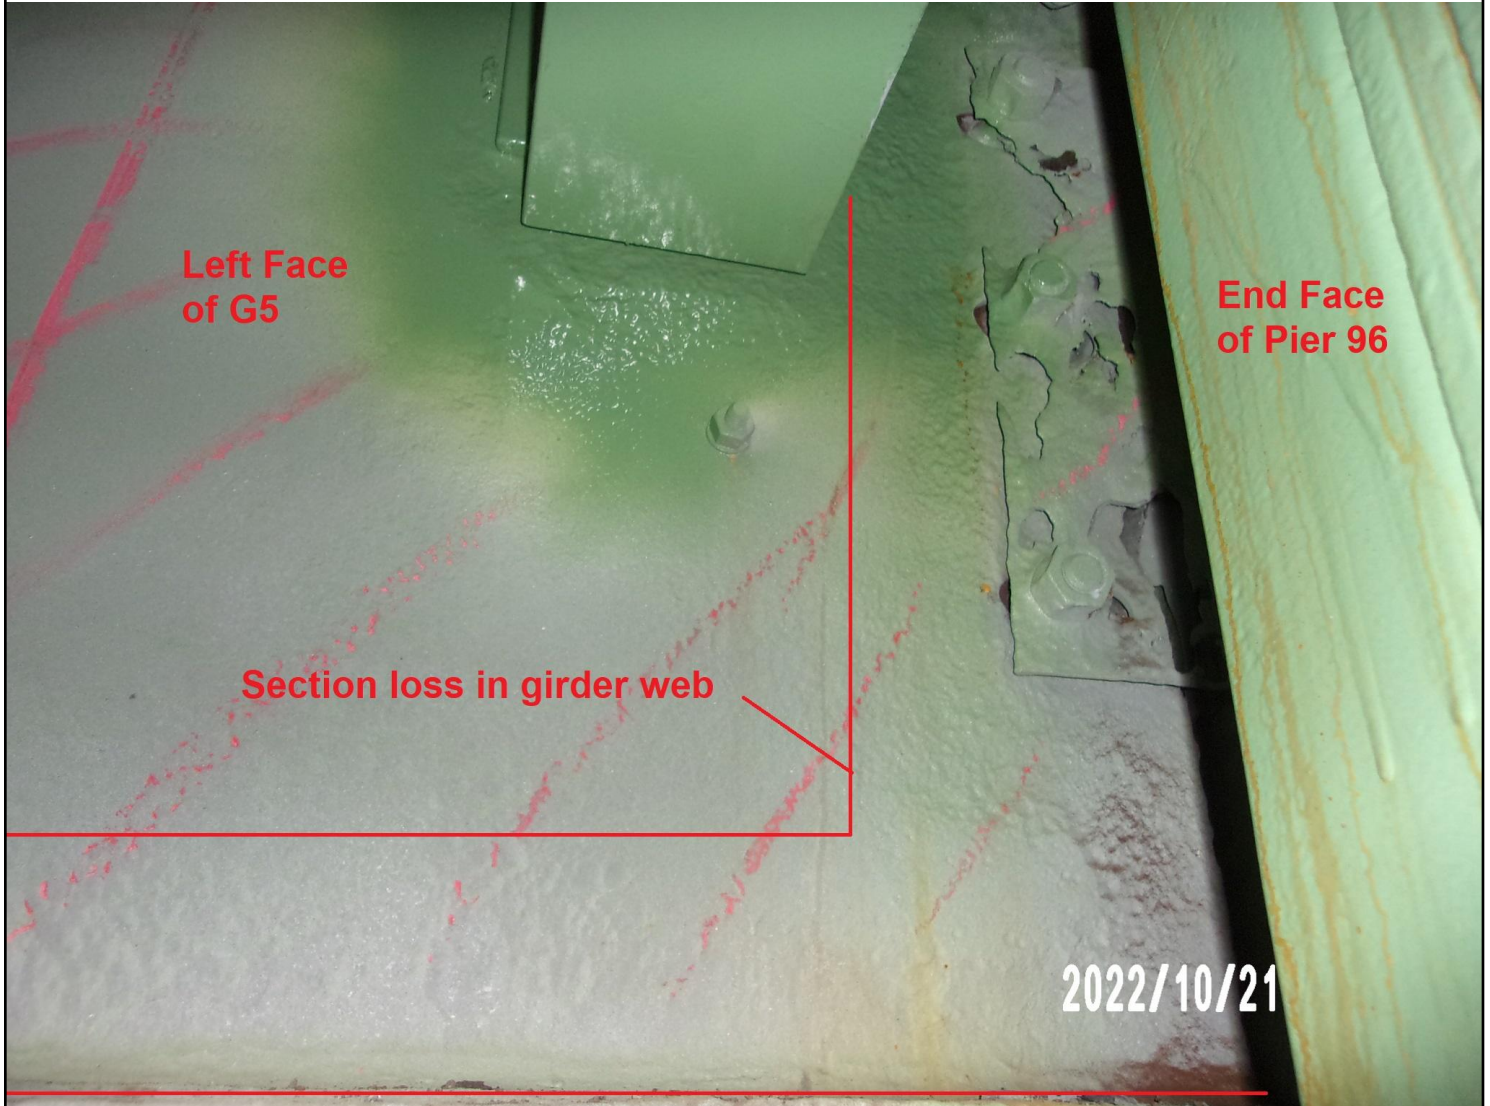
Photo Number: 6

Attachment Description: The left face of Girder G5 in Span 97 at Pier 96. The girder web exhibits severe section loss resulting in approximately 60% localized section loss in web area above the bearing, 52% overall shear web area section loss, and 60% overall bearing area web section loss. Looking Right.

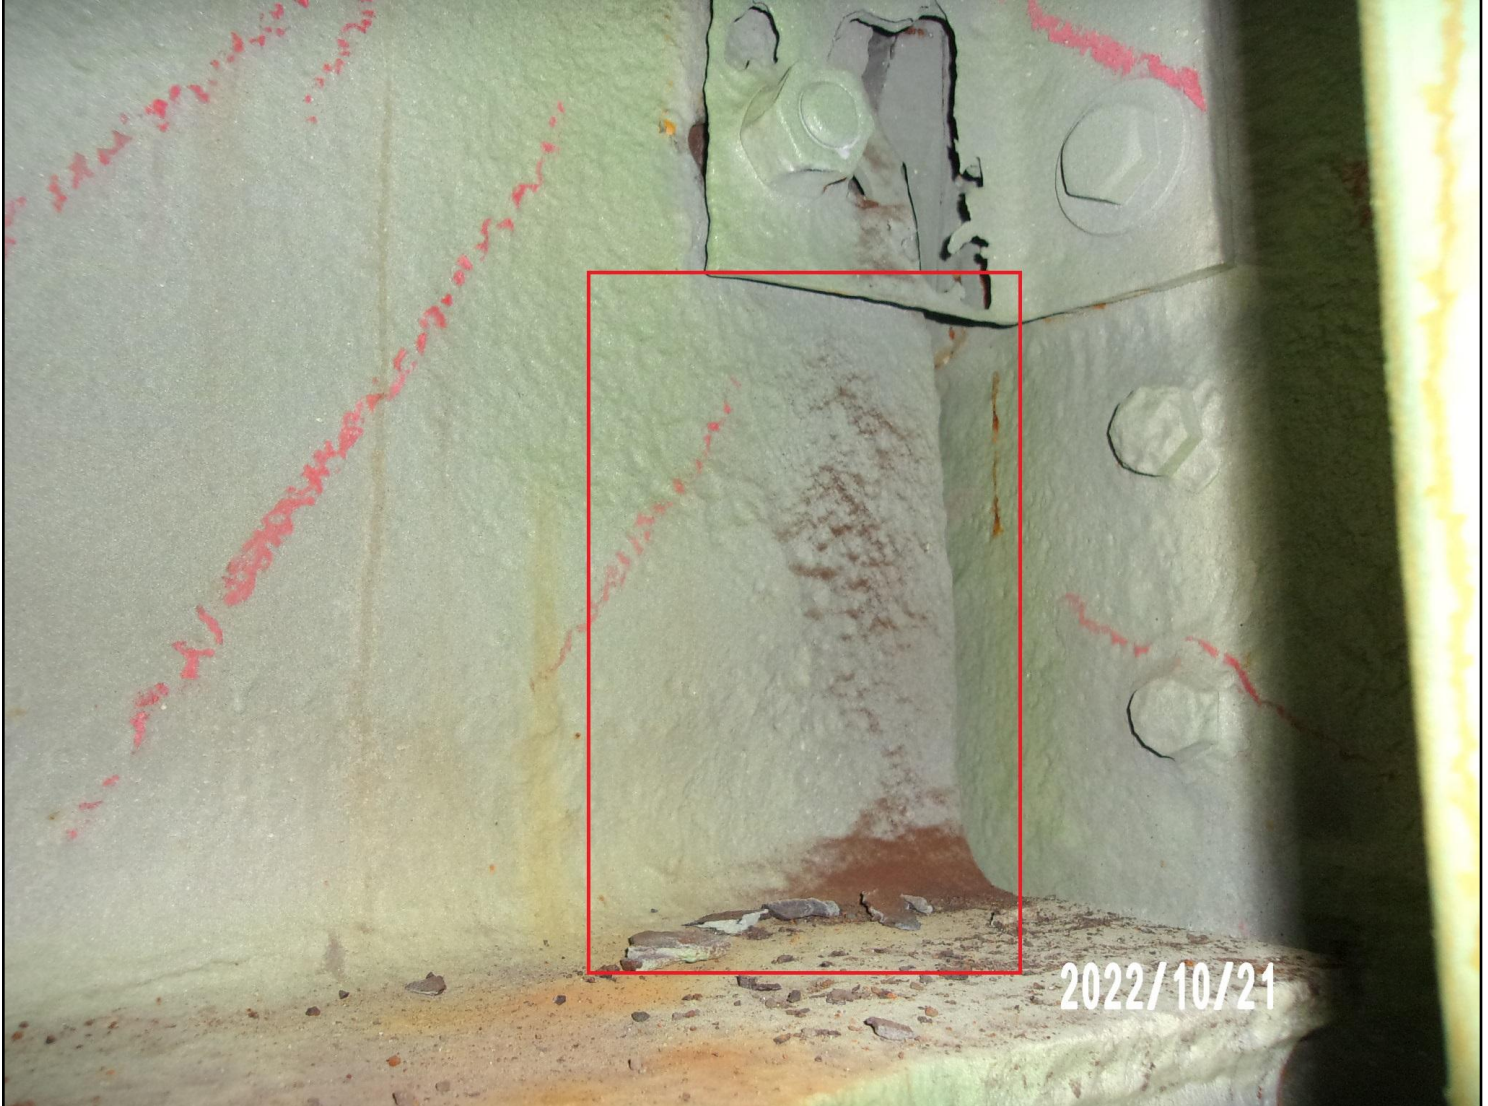
Photo Number: 7

Attachment Description: The left face of Girder G5 in Span 97 at Pier 96. The girder web area above the bottom flange above the bearing exhibits 60% localized section loss. Looking Right.

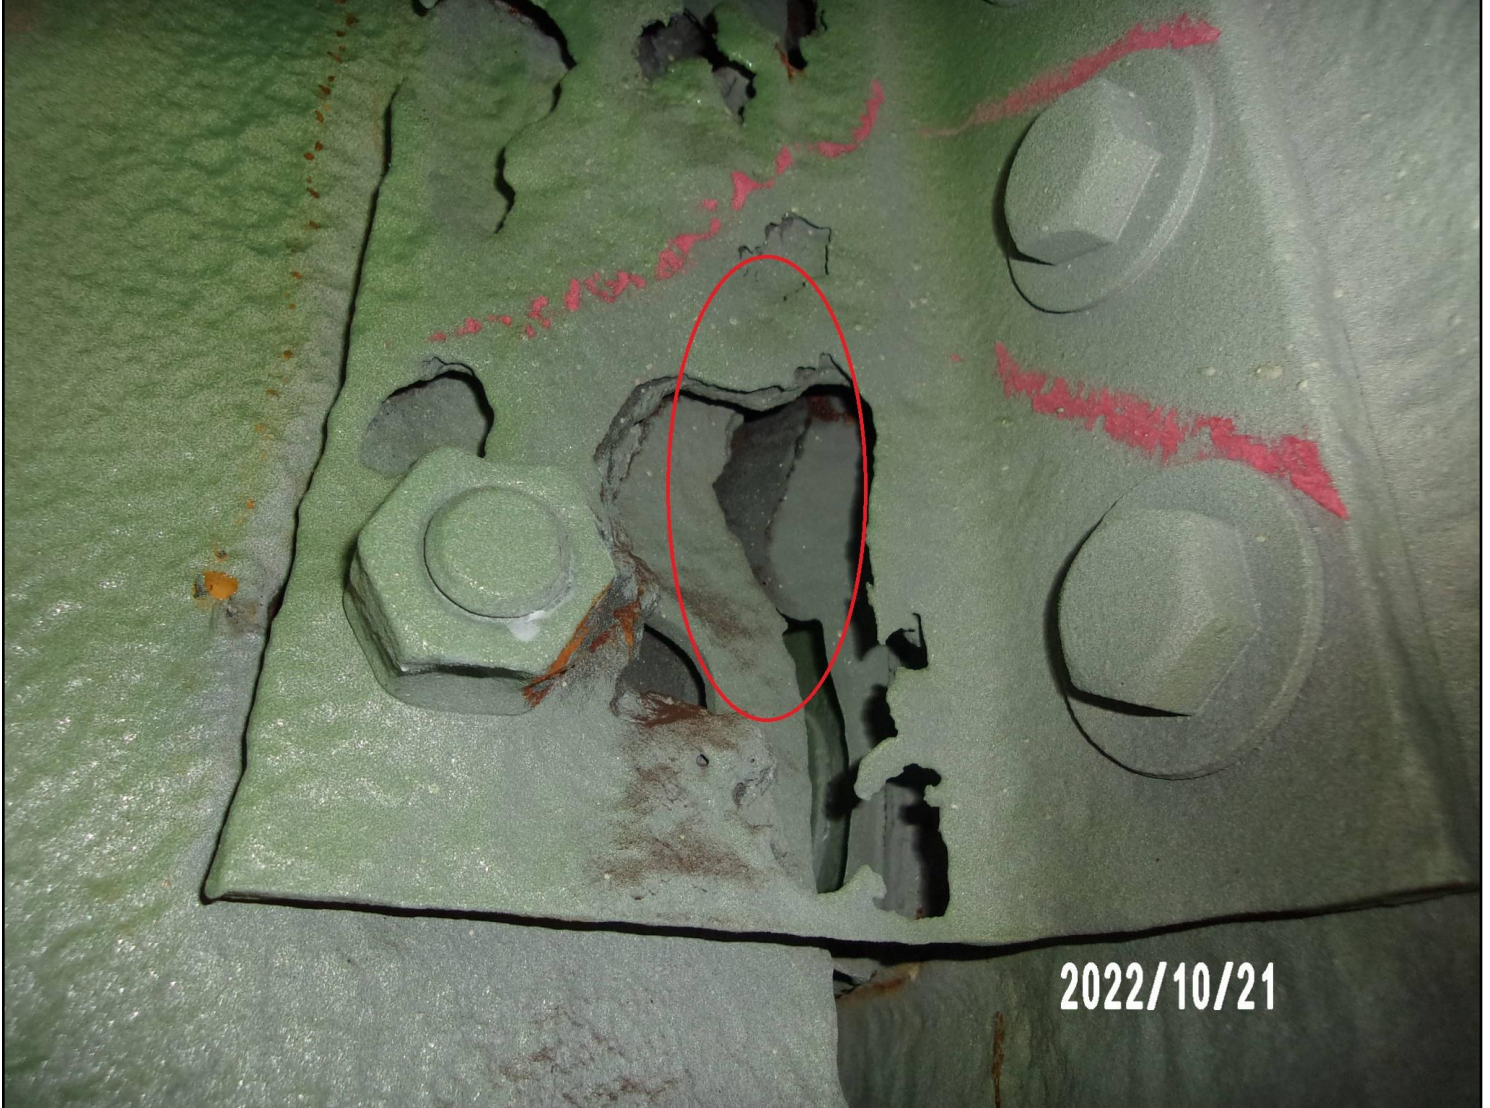
Photo Number: 8

Attachment Description: The left face of Girder G5 in Span 97 at Pier 96. The girder web exhibits 4"H x 1"W corrosion hole behind the guide angle approximately 11" from the bottom flange. Looking Right.

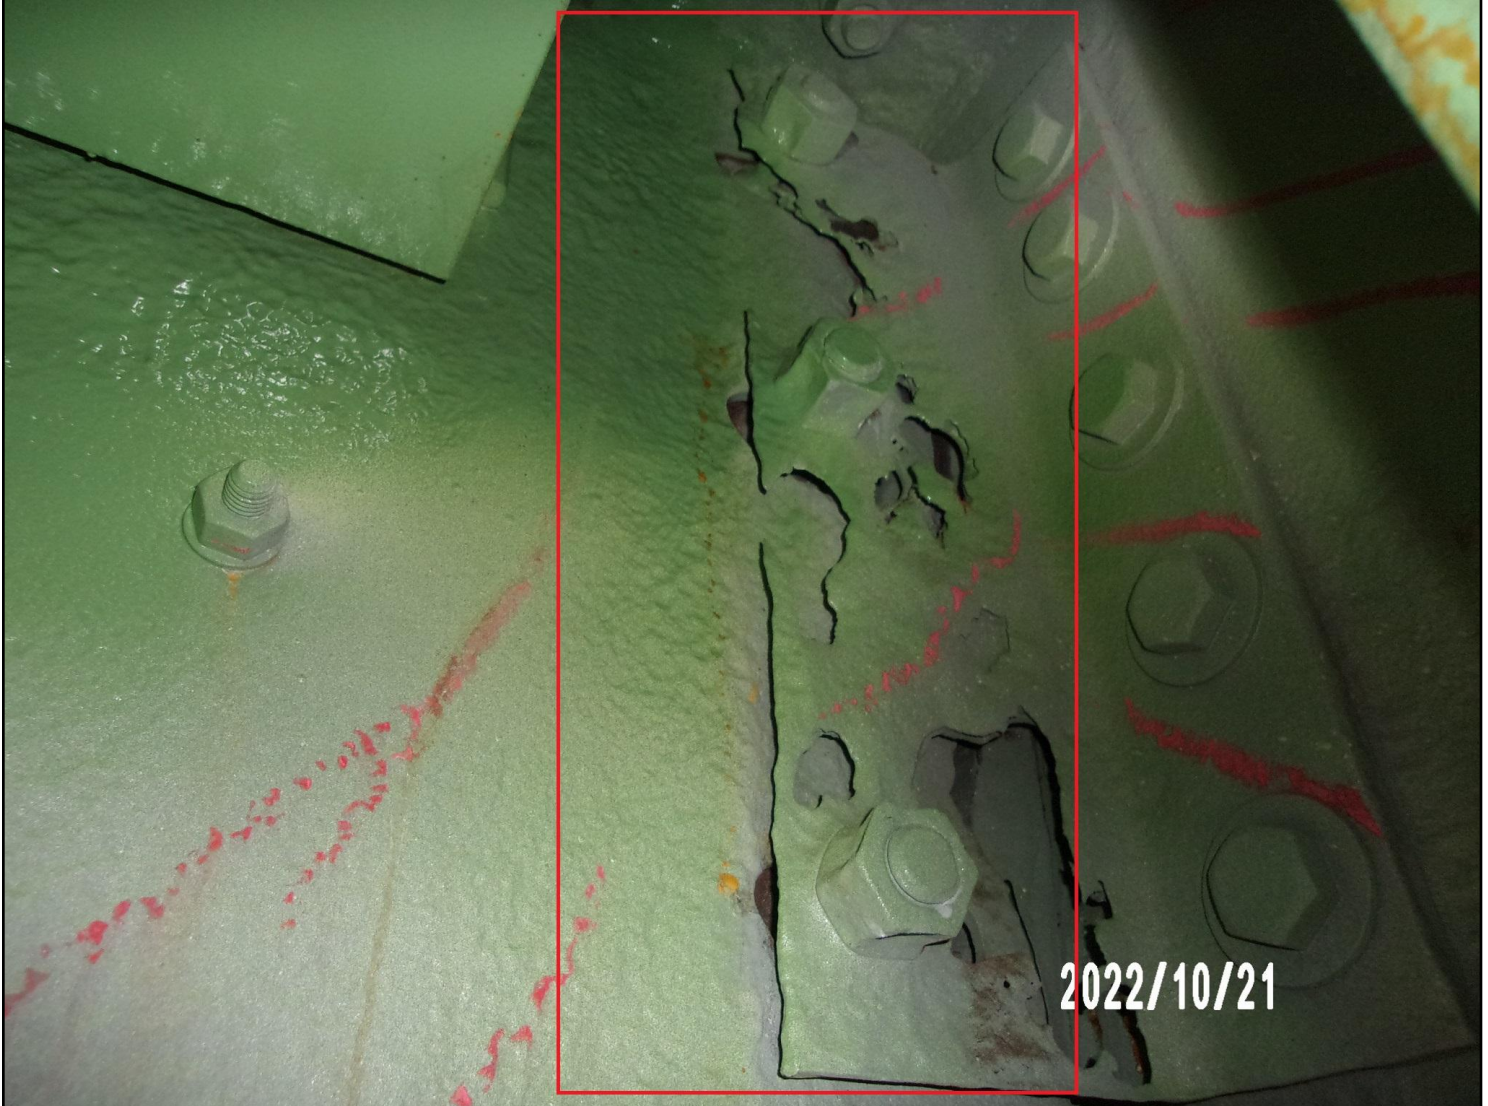
Photo Number: 9

Attachment Description: The left face of Girder G5 in Span 97 at Pier 96. The remaining web height above the corrosion hole exhibits 3/16"-1/2" RTM resulting in approximately 20%-70% section loss. Looking Right.

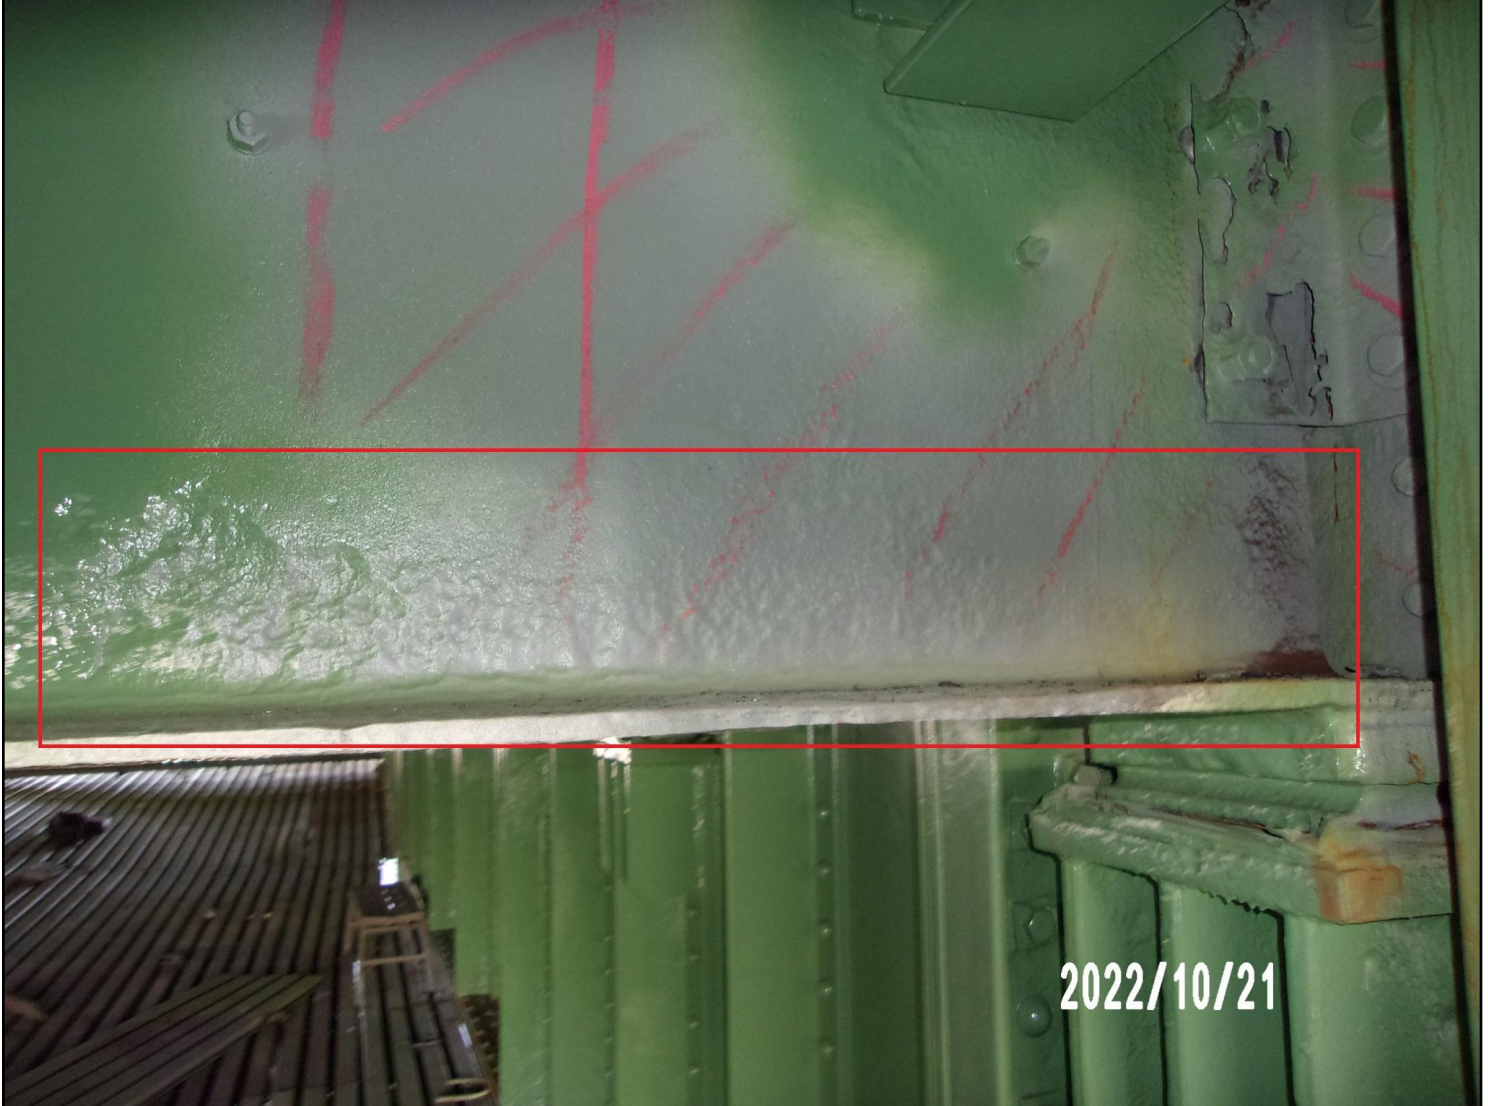
Photo Number: 10

Attachment Description: The left face of Girder G5 in Span 97 at Pier 96. The lower web above the bottom flange exhibits up to 3/16" section loss for 36"L x 5"H. Looking Right.

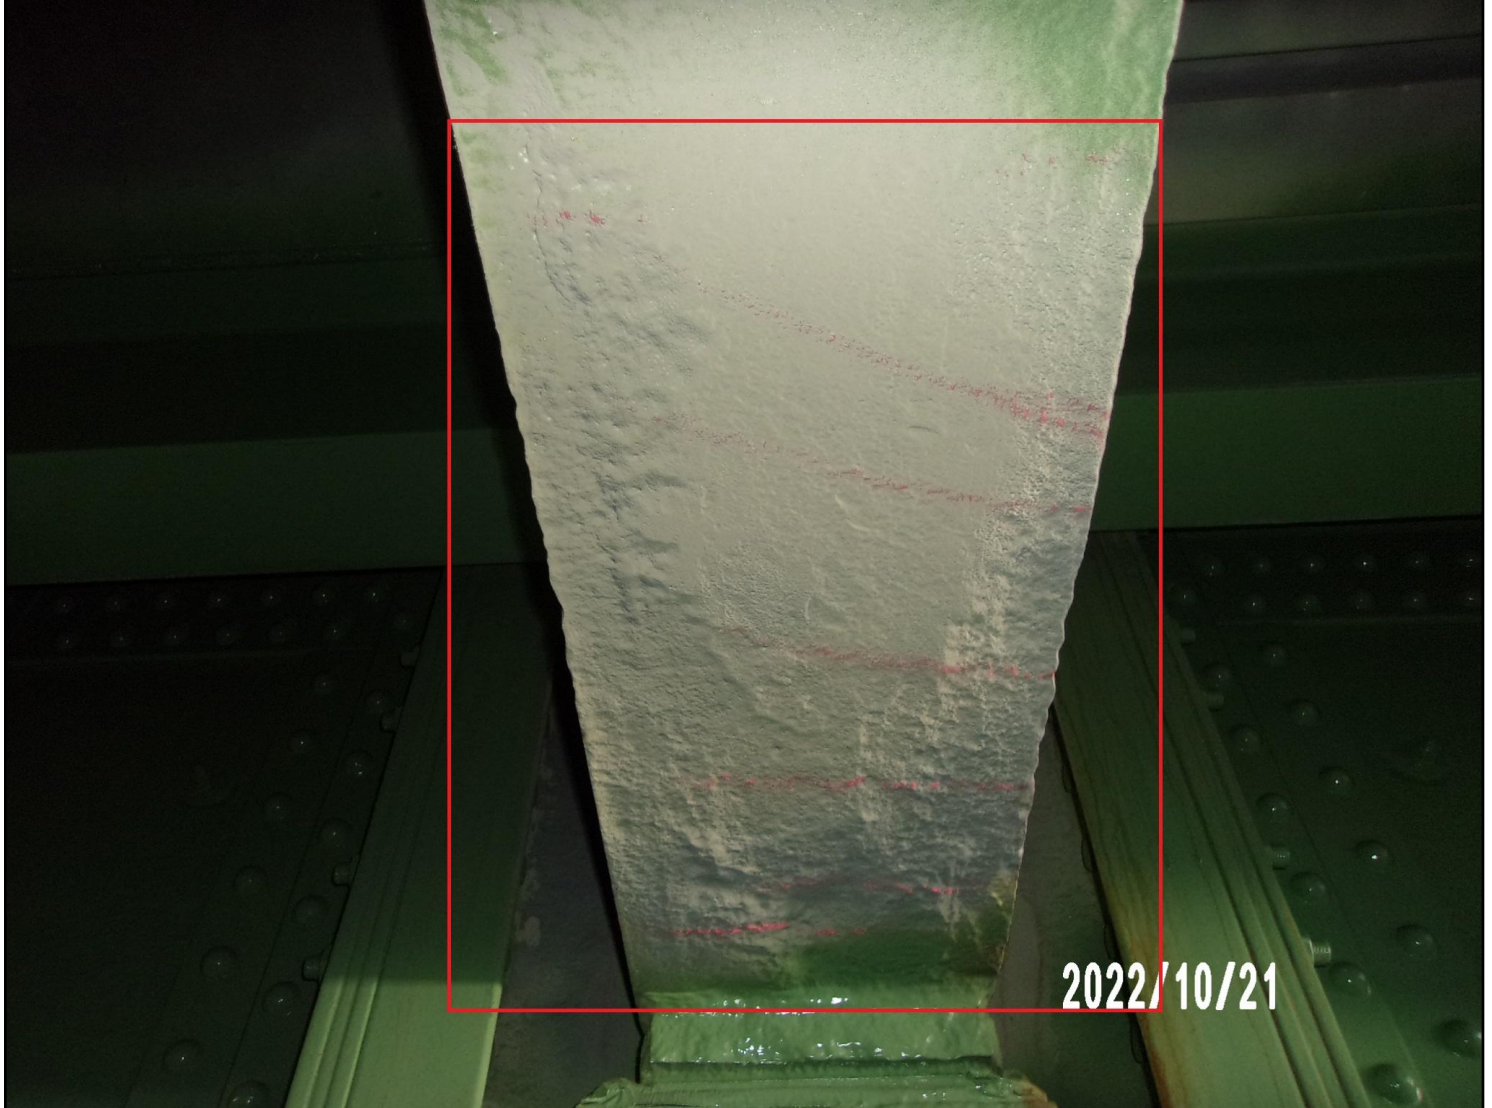
Photo Number: 11

Attachment Description: The underside of Girder G5 in Span 97 at Pier 96. The bottom flange exhibits up to 25% section loss for the full width of the flange for 24"L. Looking Begin.

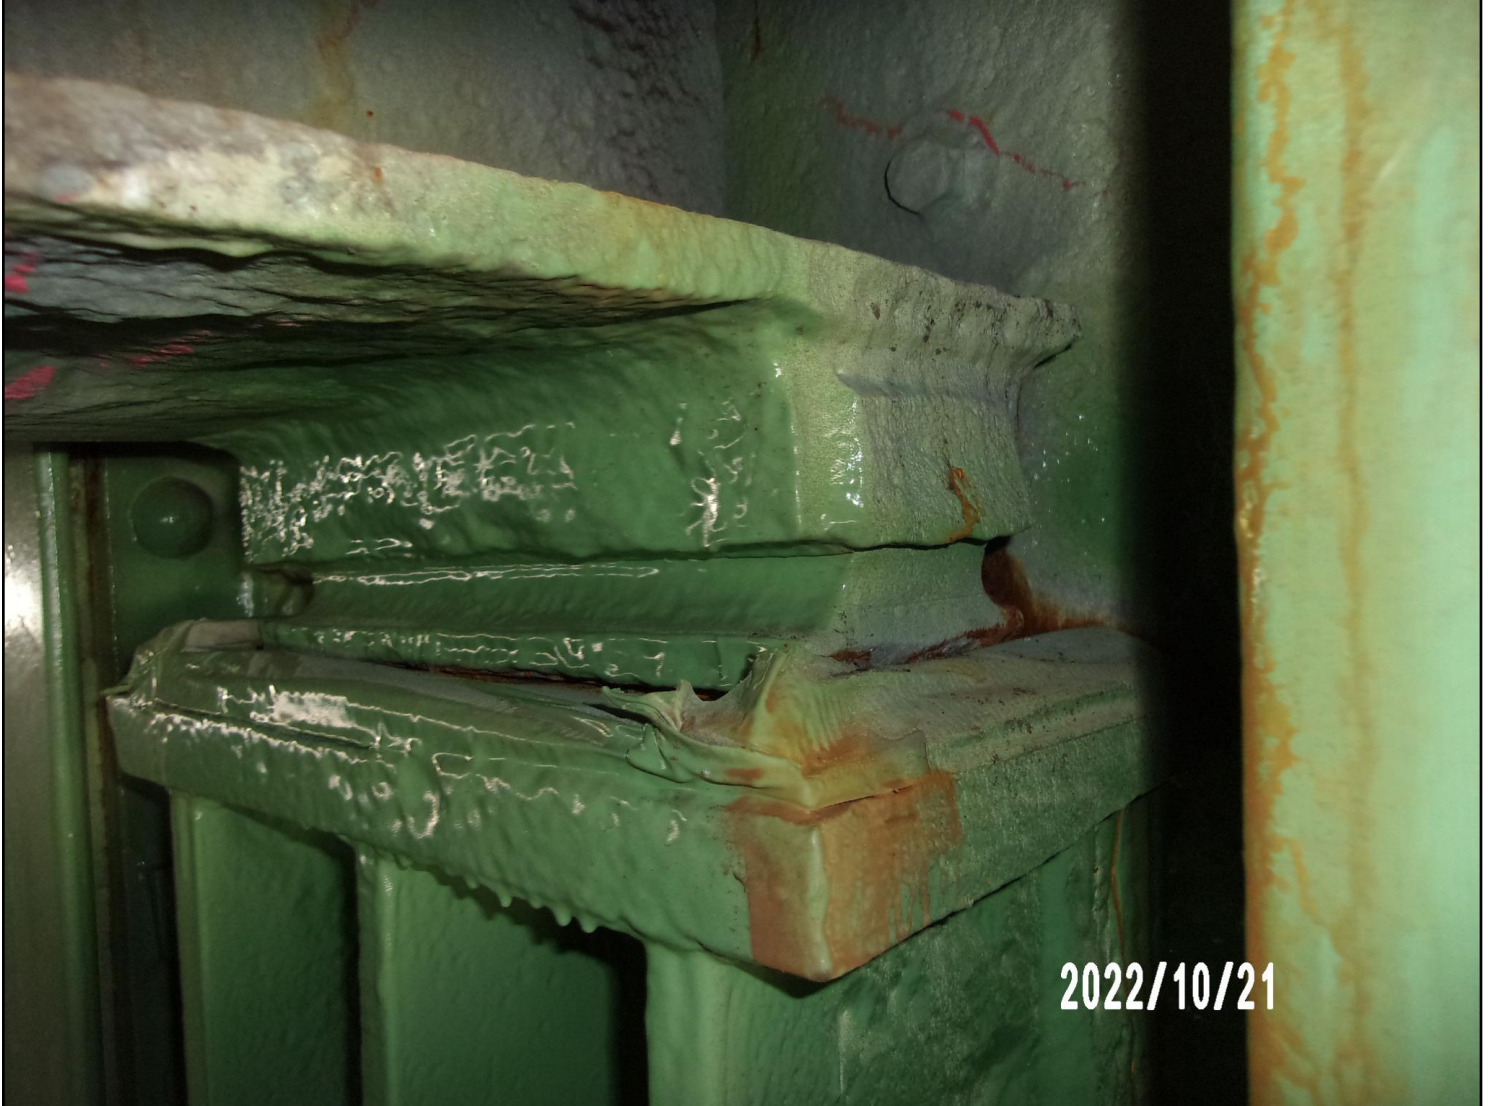
Photo Number: 12

3. Adjacent Girder G6 has previously installed steel reinforcement angles and plates.
4. The bearing under Girder G5 exhibits 15% section loss to the bearing components. (Photo 12)

Attachment Description: The bearing under Girder G5 in Span 97 at Pier 96. The bearing exhibits up to 15% section loss to the bearing components. Looking Begin and Right.
